Casting Defects - Blow holes:

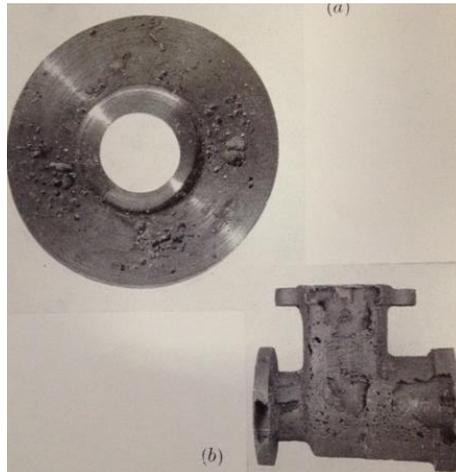
a. Wet Sand:

Localised patches of round or irregularly shaped cavities of significant size. The walls of the casting are smooth and often coloured with oxidation tints. The two examples on the left represent:

- a) 6" Ø gunmetal flange connection.
- b) Grey iron valve body casting.

Cause:

Excessive moisture in the sand

Suggested Remedy:

Reduce the moisture content or ensure even mixing.

Avoid "sleeking" (being the use of a water brush) or excessive moisture when finishing the mould.

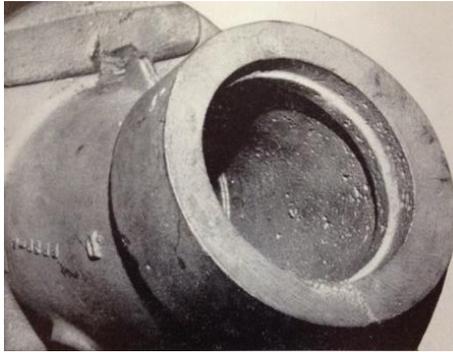
b. Surface:

This defect is characterised by localized areas of small cavities or pits on the surface of a casting. The example given below shows defects located on the inner diameter (the core side) of a small Phosphor-bronze casting containing 10%Sn, 0.3% P:

Possible Cause:

Local overheating of the mould or core surfaces

Suggested Remedy:

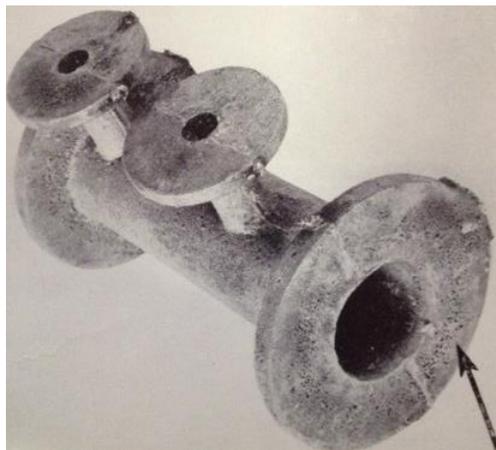
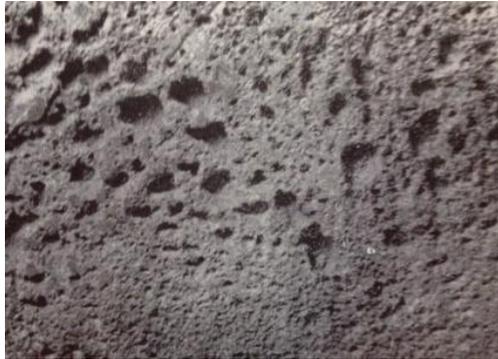
Localized areas of small cavities/pits on the surface of the casting. The picture on the left shows defects on the flange of a 4'' bore branch pipe in Ni-Cr Iron alloy cast in dry sand. This defect usually occurs on heavier sections of castings which solidify at a slower rate than the thinner sections. Rule of thumb suggests that it is most commonly experience on castings ½'' and over. Stainless and other high alloyed steels are susceptible to this defect.

Possible Cause:

Reactions between the molten metal and the water vapour in the mould or mould dressing is the most likely culprit contributing to this type of defect.

The above picture is an enlargement of the above picture of which the area expressed is indicated by the arrow.

Suggested Remedy:

Use a mould dressing that will not evolve water vapour when heated. Mould dressings bonded with such materials such as ethyl silicate provide satisfactory

results. Defects may also be minimized by the use of permeable well dried moulds made from either oil bonded sand or synthetic sand containing a minimum amount of clay bond. Avoid local overheating of the mould or core sand by proper methods of running.

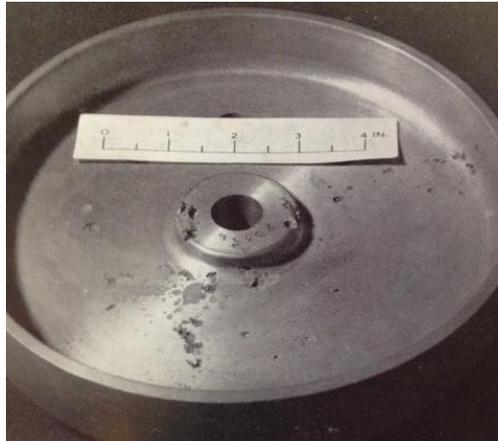
c. Sub Surface Slag Reactions holes:

This type of blow hole is unique in appearance as it consists of small holes with rounded or irregular shapes which may at times contain shot/grit at or just below the casting surface. These blowholes mainly occur particularly on top surfaces and below cores. They may be revealed on cleaning or after machining. These holes have discoloured surfaces which are often associated with slag inclusions and sand grains.

Possible Cause:

Fluid containing slag and manganese oxides entering the mould could react with the metal. High manganese content and high sulphur contents coupled with low pouring temperatures favour this kind of defect.

Suggested Remedy:

Avoid very fluid slags formed by oxidation of the metal in the ladle, or coming from low melting point refractories such as botting clays. Skim the metal thoroughly, use strainer cores, slag traps and good gating practices. Keep the runners full of metal. Reduce the manganese content to a level just adequate to balance the sulphur content ($Mn = 1.7 \times S\% + 0.3$), reduce the sulphur content and raise the pouring temperature.

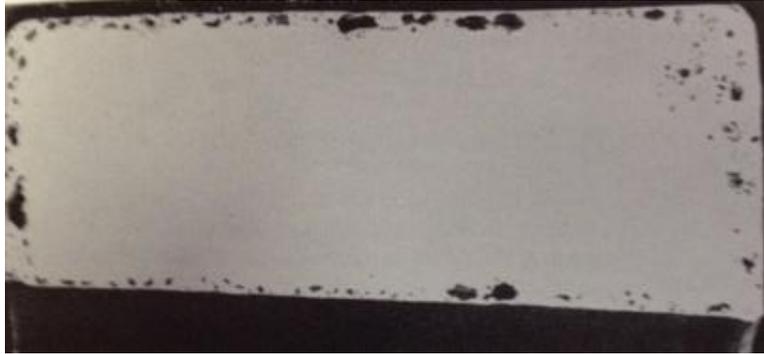
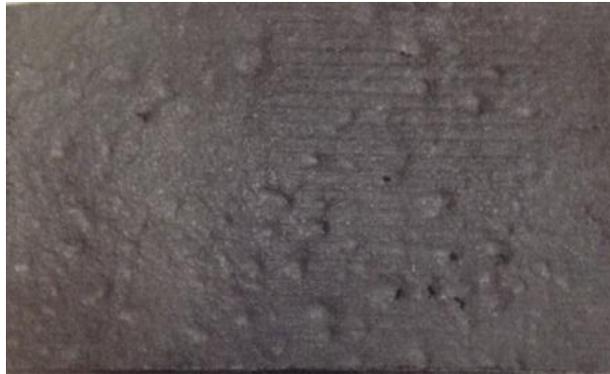
d. Sub Surface:

Small cavities adjacent to the surface of the casting (and usually on all surfaces of the casting). In many cases the surface of the casting appears to be normal (which makes this a difficult defect to identify in the as cast condition). In some cases however, surface pitting may be present as illustrated below:

Possible Cause:

This type of defect is caused by a reaction of the molten metal with the moisture in the moulding sand. This is mostly associated (but not always) with high pouring temperatures and is encouraged by insufficient de-oxidation, insufficient permeability in the sand and insufficient ventilation

Suggested Remedy:

Reduce the volatile content in the mould cores and dressing. Ensure that the material is sufficiently de-oxidized. Increase the level of ventilation and increase the permeability of the sand. Reduce the pouring temperature if possible.

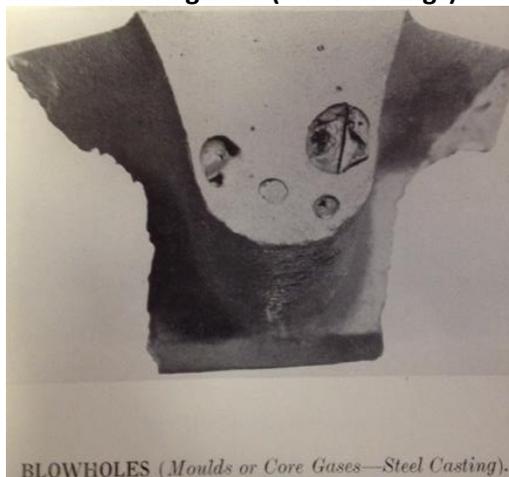
e. Mould or core gasses (Steel Castings)

Round shaped holes with bright smooth walls which normally present themselves once the casting is sectioned as shown above. In some cases where blowholes has appeared from concentrated pellets of other materials such as clay in the mould, the defect may migrate to the surface of the casting.

Possible Causes:

Significant/excessive evolution of gases from the mould or core sand together with low permeability and insufficient venting of the mould or core. It may also be the result of improperly mixed mould and core sand.

Suggested Remedy:

Make sure that the sand is properly mixed and milled and that the materials (i.e. bonding) are dispersed uniformly throughout the mix. Ensure that the cores are dry and properly baked. Make use of less organic binders or additions and increase the permeability/ventilation of the sand/mould.

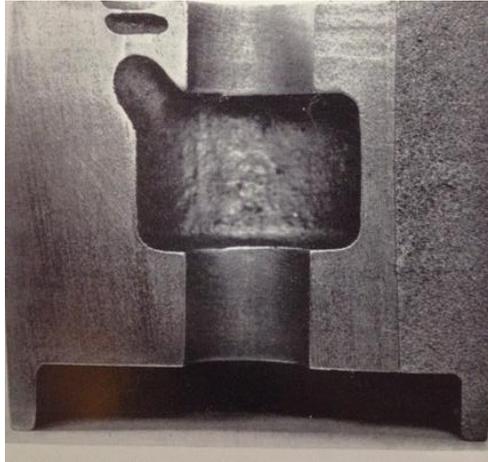
f. Mould or core gasses

This defect appears with smooth walls and a round orientation. The source of the issue is often difficult to identify unless the casting is sectioned. The picture below is a 100mm \varnothing grey cast pulley wheel casting showing blowholes from the core.

Possible Cause:

Excessive gas build up from the moulding or core sand coupled with insufficient permeability or venting. May also be a result of metal entering the core vents.

Suggested remedy:

Use less oil binder. Ensure that the cores are sufficiently dry and properly baked. Increase the permeability of the sand and ensure that the mould and cores are properly vented. Ensure that the sand is properly mixed and free of local contractions of core binder, coal dust, etc

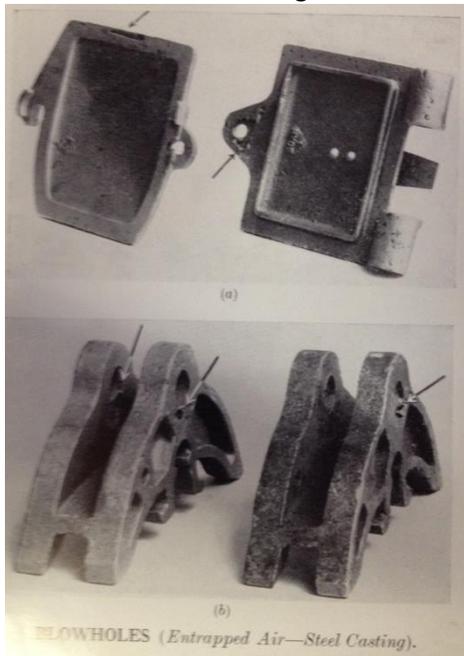
g. Entrapped air – Steel Castings:

These blowholes appear to be round with smooth out walls found on or just under the surface of the casting

Both of the pictures (a) and (b) are small castings with wall thicknesses ranging from 6 – 19mm in cross section. Both items were cast in green sand.

Possible Cause:

Entrapped air

Suggested Remedy:

Increase the permeability of the sand as well as the venting of the mould. Try and avoid fast and turbulent metal flow into the mould.

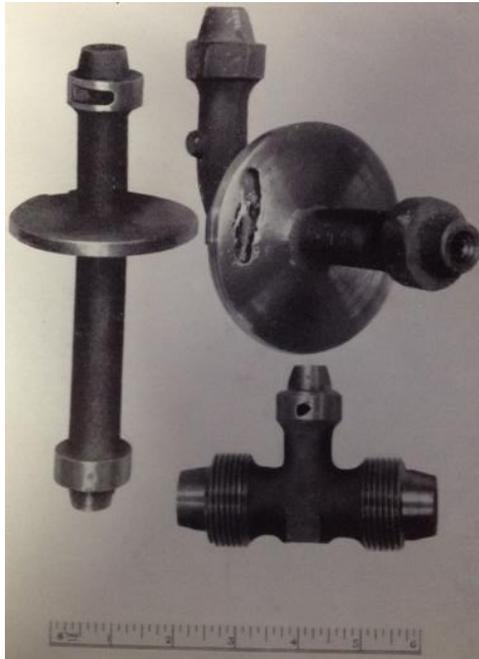
h. Entrapped air:

Elongated cavities of appreciable size consisting of smooth walls located on or just below the surface of the casting located near the highest part of the cast component.

Possible Cause:

Entrapped air

Suggested Remedy:

Make use of a vent in the affected area. Wire may be used to increase the permeability of the sand should the surface finish of the product allow for it. Check the degree of ramming or mould hardness at the affected areas.

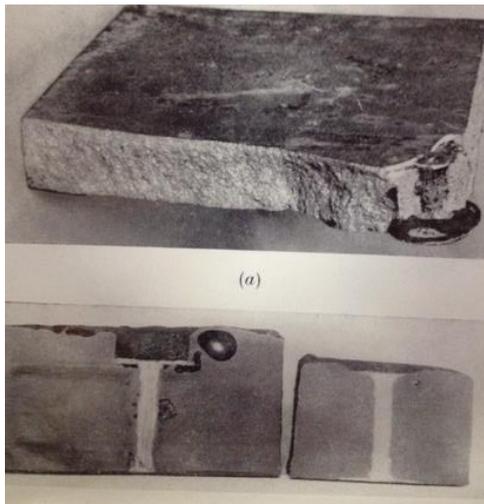
i. Chaplet:

Smooth-walled cavities adjacent to Chaplets which are round or elongated in appearance. This defect is more often than not associated with issues associated to the fusion of the chaplet with the casting and may cause leakage when exposed to pressure.

Picture (a) and (b) show blowholes and imperfect fusion of the chaplet in a grey cast iron. (c) shows good fusion of chaplet with metal.

Possible Causes:

Rusty, Dirty, Damp or improperly coated Chaplets

Suggested Remedy:

Make sure that the Chaplets are clean, dry and free of contamination. Bright iron steel chaplets are deemed to be satisfactory when used immediately. However they may cause blowing if allowed to stand in the mould (long enough for rust to develop). The use of Tin-coated or Copper coated chaplets is recommended to avoid this issue. Zinc or alloys containing Zinc are problematic for chaplets as they will also cause “blowing”
